Manhole Inspection Summary

Manhole # S35KK_017MH

Insp Date: **3/8/07 12:49 PM**

Location Address: **1913 CALVERT ST**

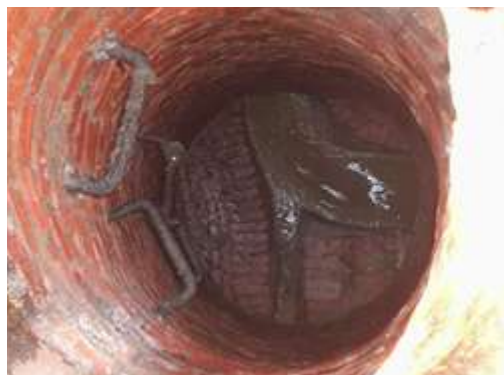
Top View

Adjustment deterioration and infiltration.
Corroded steps. Evidence of surcharge -
Bench debris.

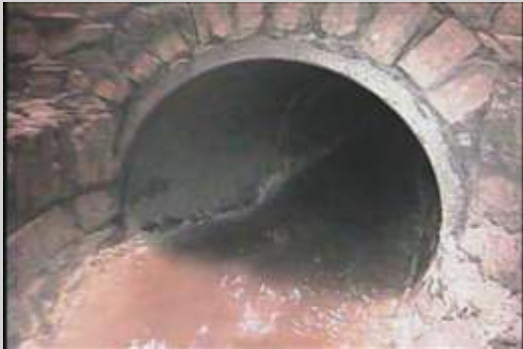
18 in. Circular Gravity Sewer Pipe Out @ 12 O'Clock

Barrel deterioration and infiltration. Channel deterioration.

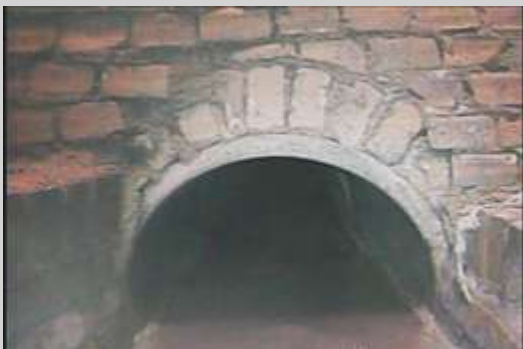
18 in. Circular Gravity Sewer Pipe In @ 3 O'Clock

Barrel deterioration and infiltration.

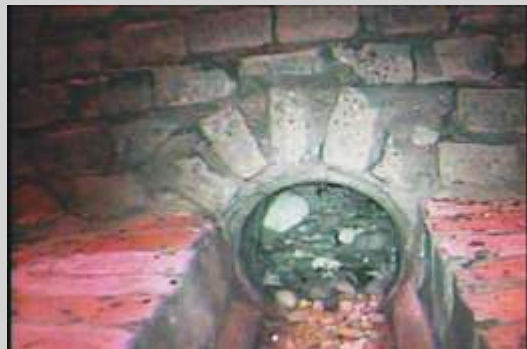
Pipe In @ 6 O'Clock

Connects To: **Stub connection / abandoned**
☐ Possible Illicit Connection
